DDASaccident531

DDAS Accident Report

INVESTIGATION REPORT INTO MINE ACCIDENT

WHICH OCCURRED ON 04th MARCH 2004 AT M4101 MINEFIELD, O'Chrey Village, Kamreing Commune, Kamreing District, Battambang PROVINCE

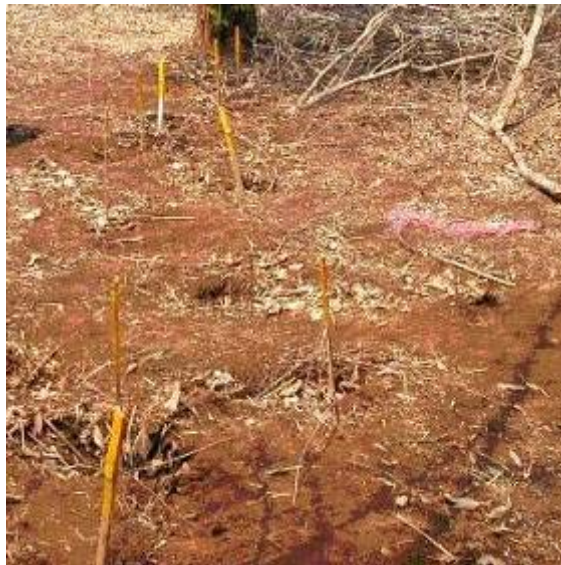
[Photograph showing discovered mine-line marked with yellow topped stakes.]

The Victim deliberately walked outside the marked area, using a path that he and others frequently used. The line of previously discovered mines was close to, but inside, the perimeter tape. Clearly the hazardous area had not been marked appropriately during survey. That is not unusual because accurate survey is very difficult, but it is why the primary cause of this accident must be listed as “Inadequate survey”.

The secondary cause is listed as a “Field control inadequacy” because the extent of the hazardous area had not been appropriately adjusted after a mine line had been found. Generally, a distance of at least five metres (normally ten) on both sides of a mine-line will be cleared. This is intended to catch “strays” that may have been moved by weather or may have been used to “patch” the original mine-line after mines have detonated. If this had been done, the mine just outside the perimeter tape would have been found during clearance.

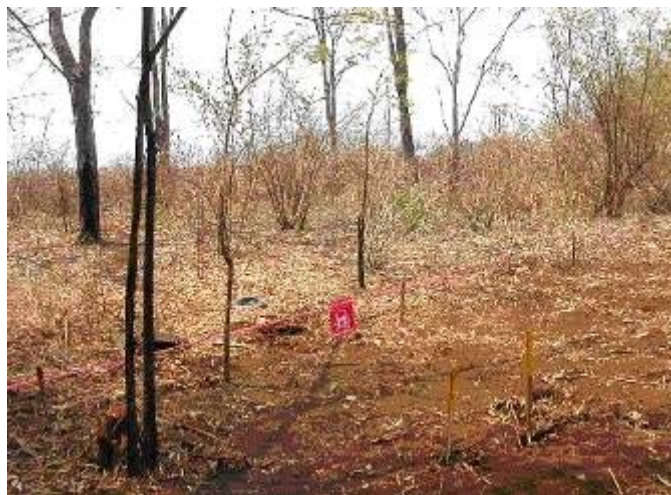
[The accident site, the Victim's hat can be seen where it fell.]

For the case 09 March 04: Based on the nature of injury, the answers of the victim and the scrape at the accident spot [crater], it was caused by PMN Anti-personnel mine while he was stepping out the cleared minefield boundary to go to toilet in the forest.

Yes. It breached Manual Demining SOP 108. The victim himself ignored the boundary of minefield even though it was clearly marked, he might perceive the hazardous area as a safe track where he saw villagers frequently walking through and he sometimes walked along that track as well.
